TWR-17546  
Volume II

Flight Set 360L007 (STS-33R)  
Case and Seal Final Report  
Volume II

February 1991

***Thiokol*** CORPORATION  
SPACE OPERATIONS

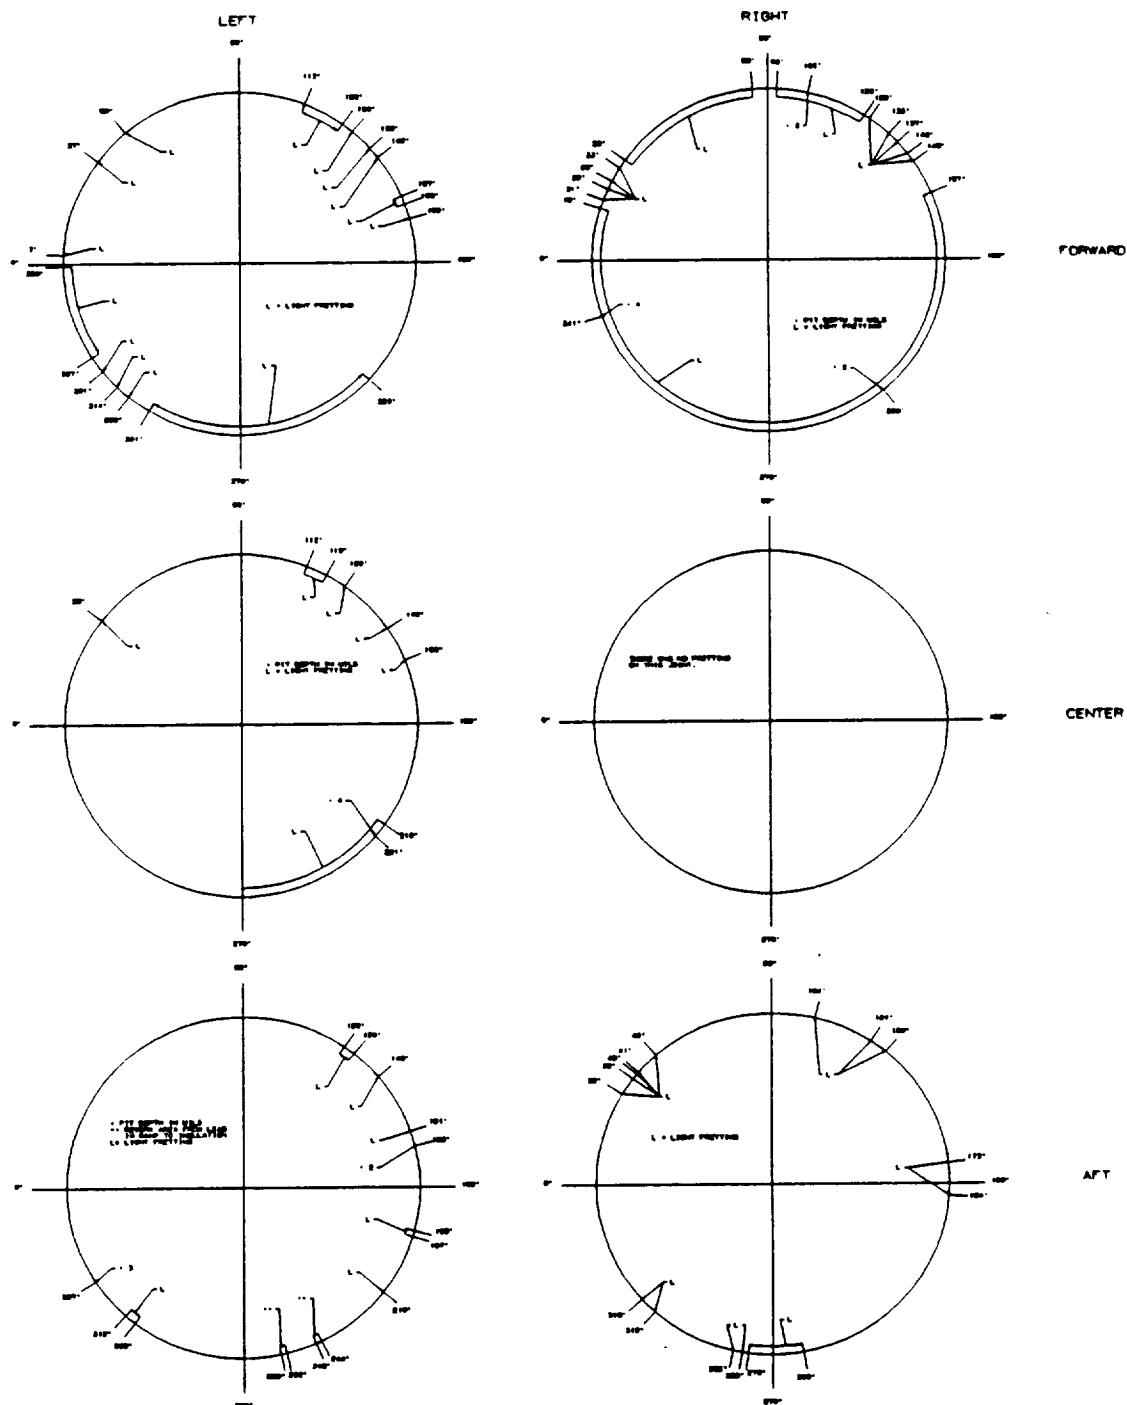
Figure 5. Field Joint Fretting Summary

The post-flight assessment of both motors showed the case segments to be in good condition. Field joint fretting indications on this flight set ranged from none on one joint through light ( $<0.003$  inch deep) on most of the joints to locally medium ( $>0.003$ ,  $<0.005$  inch deep) on two joints. Figure 5 visually summarizes the fretting on all the field joints. No new fretting was found in old fretting locations. All fretting was mapped from the inner clevis leg. The capture feature fretting was not mapped due

- LH/FWD Light fretting (0.000 to 0.003 inch deep) at 37, 50 degrees. Intermittently light from 112 to 142, 157 through 165, and from 223 through 0 through 3 degrees.
- LH/CTR Light fretting at 38, 112 through 119, 126, 146, and 158 degrees. Intermittent light fretting from 216 through 270 degrees. A moderate fret of 0.004 inch deep was observed at 221 degrees.
- LH/AFT Light fretting at 125 through 129, 140, 161, 166, 195 through 197, 218, 244 through 246, 256 through 258, 308 through 312, and 327 degrees. This joint had fretting from a previous flight from 185 through 220 degrees.
- RH/FWD Intermittent light fretting around entire circumference of joint. A moderate fret at 341 degrees, and no heavy frets.
- RH/CTR No light, moderate, or heavy frets.
- RH/AFT Light fretting at 32 through 41, 49, 104, 124, 130, 173, 184, 260 to 283, 312 to 318 degrees. No moderate or heavy frets.

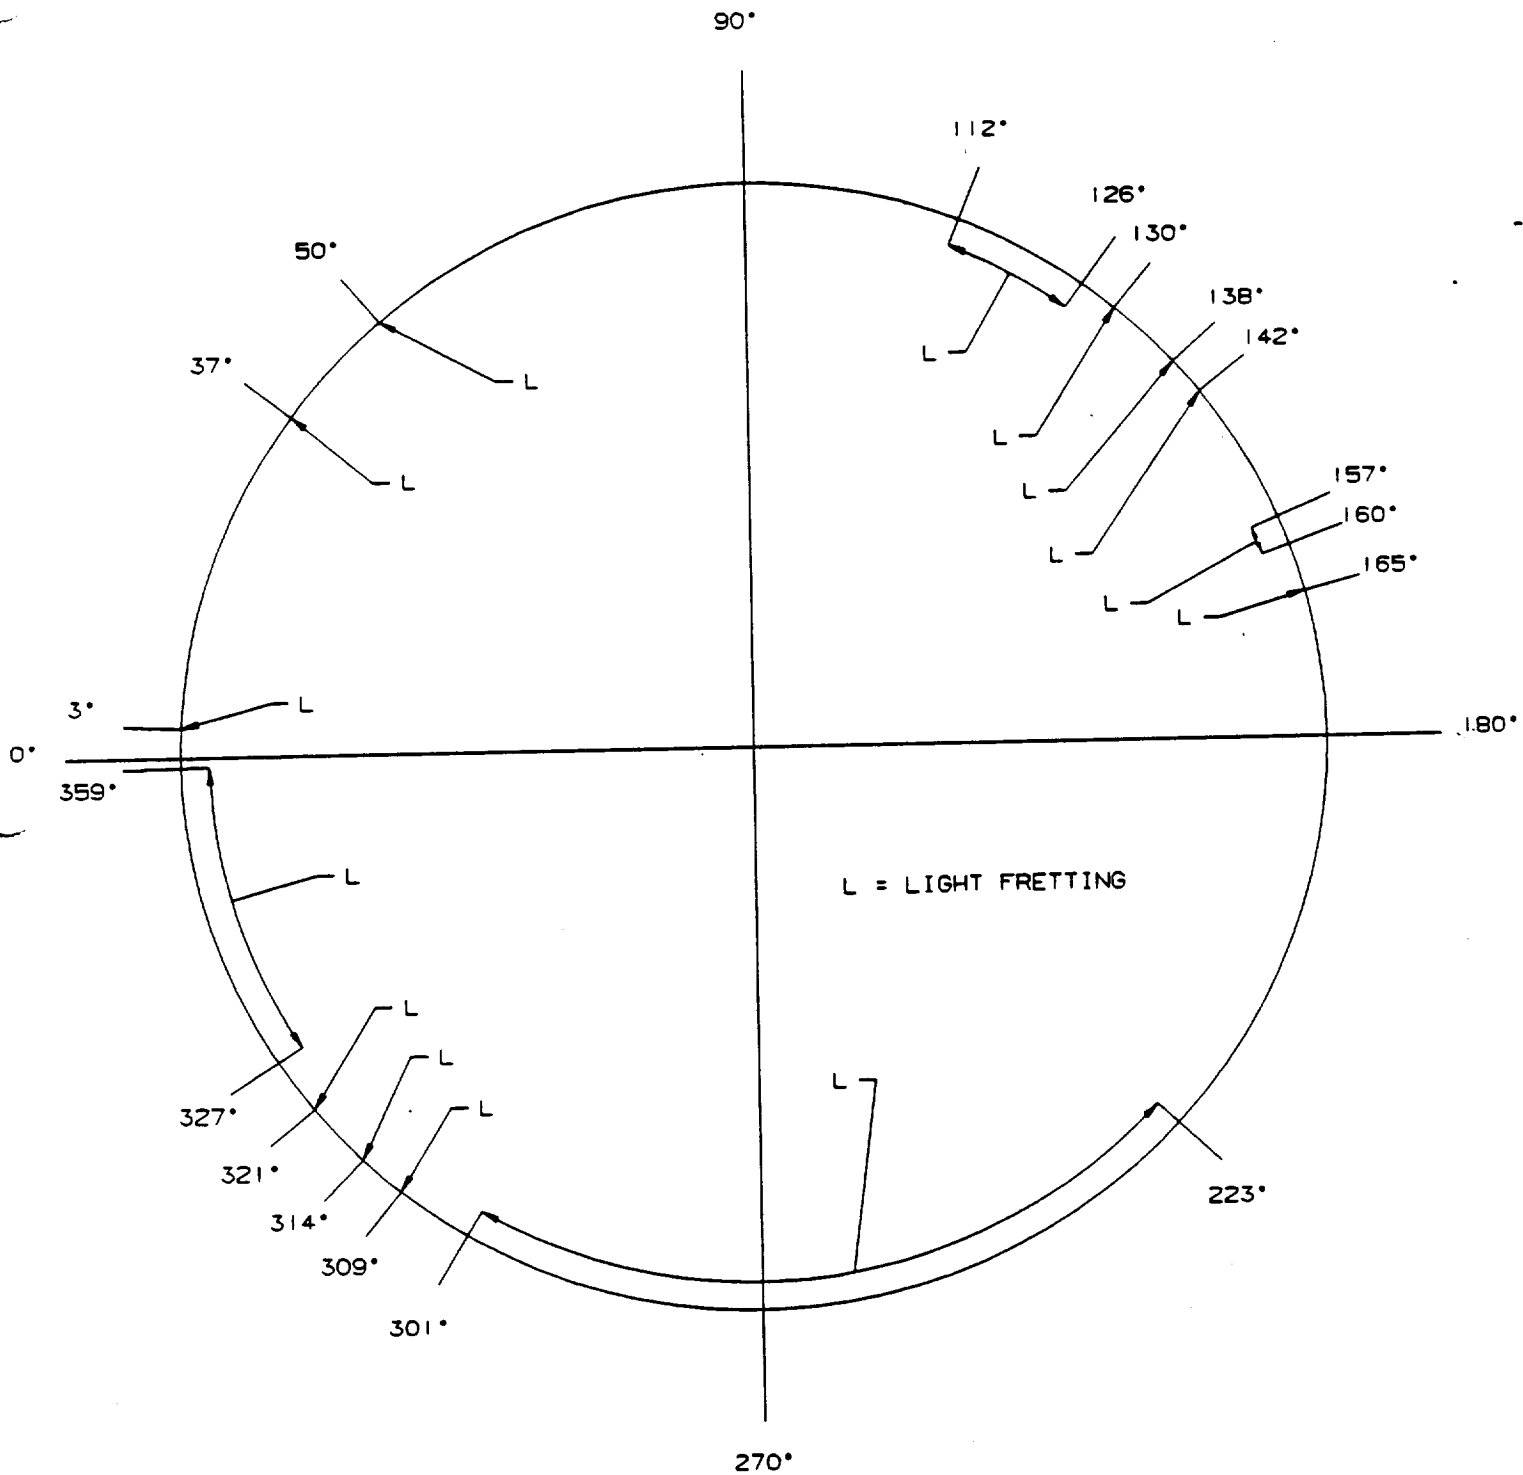
Figure 6. LH Forward Field Joint Fretting

Assessment of the metal components found light fretting at 37, 50, 112 intermittently through 142, 157 through 165, and 223 intermittently through 0 through 3 degrees. Figure 6 gives a detailed view of the fretting.

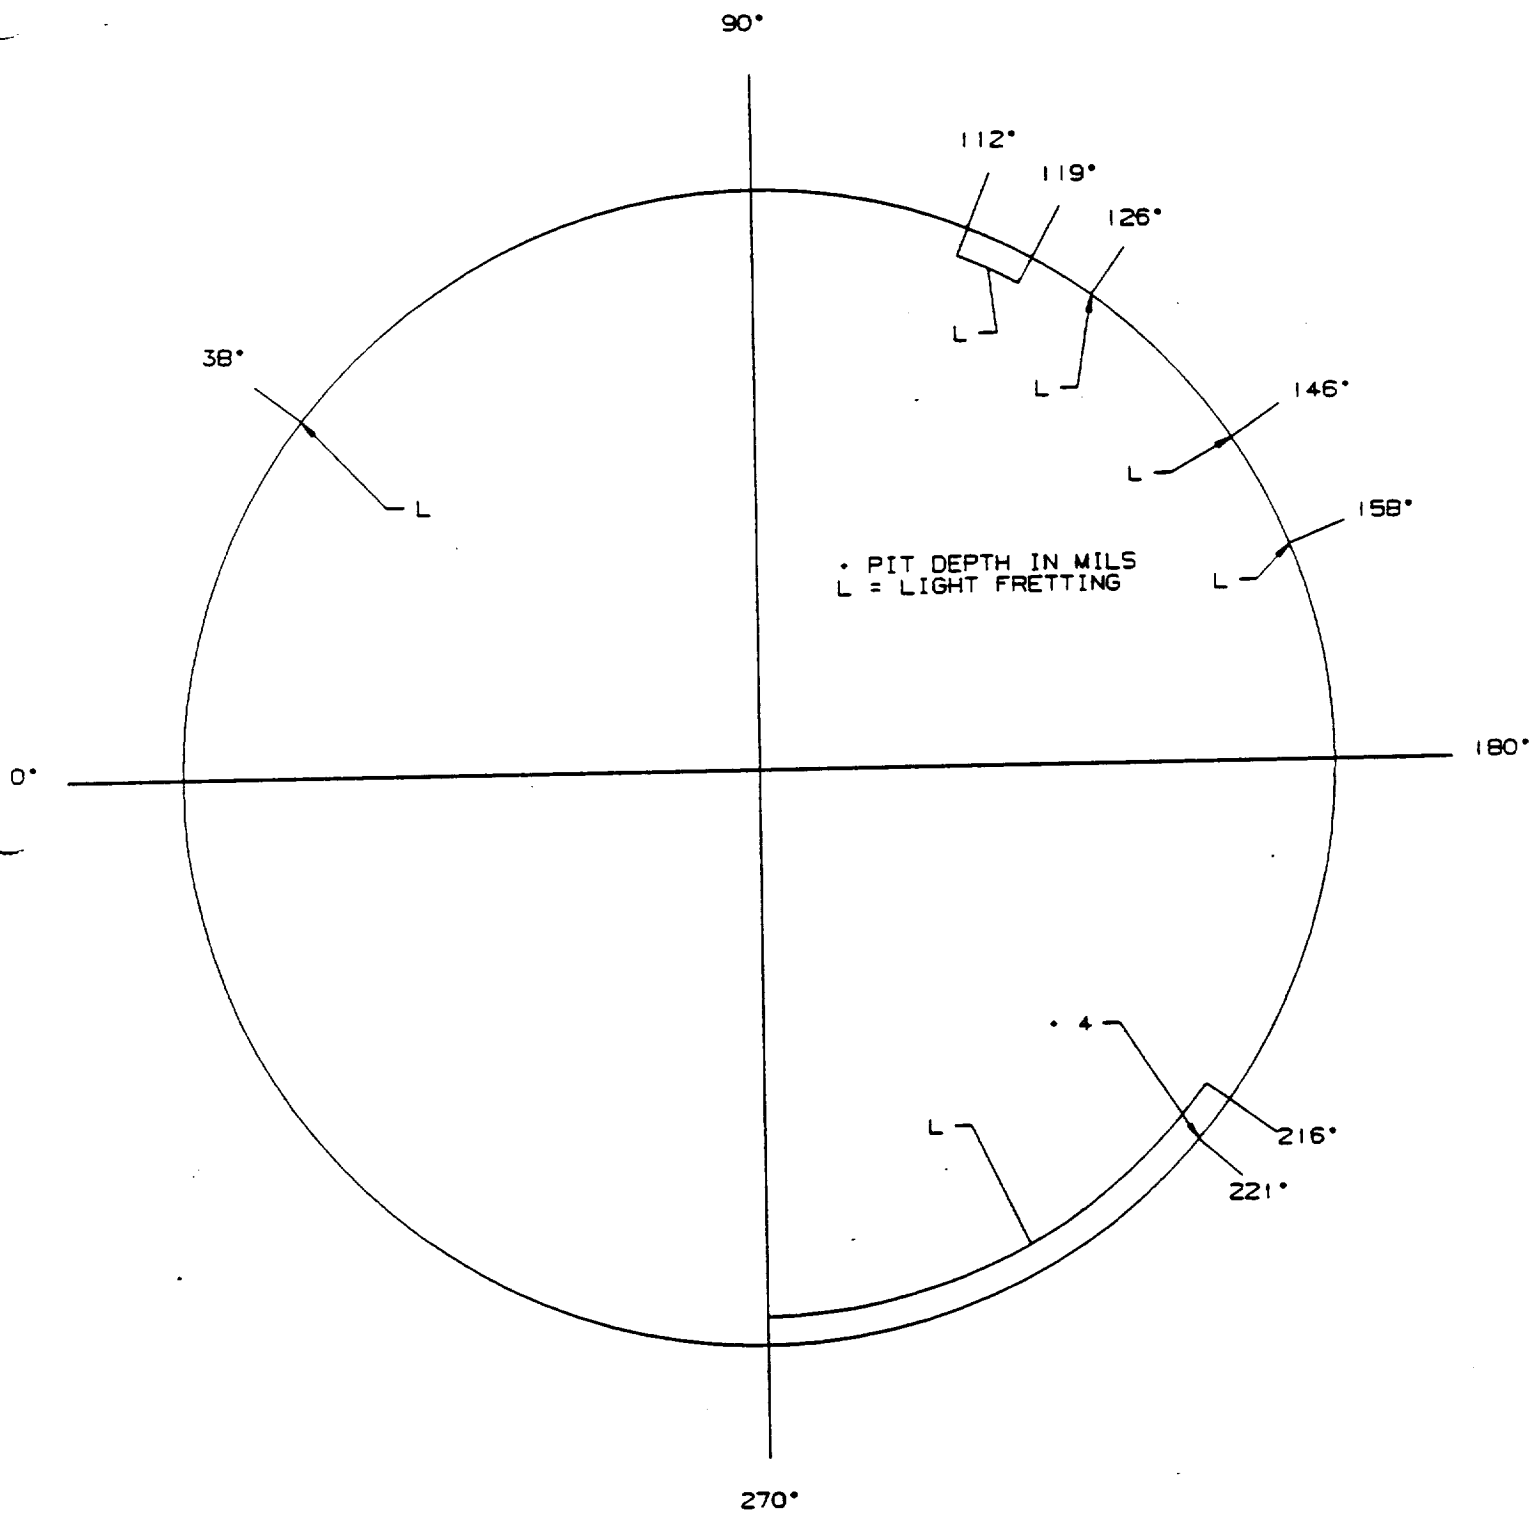
Figure 7. LH Center Field Joint Fretting

Assessment of the metal components found light fretting at 38, 112 through 119, 126, 146, 158, and intermittently from 216 through 270 degrees. A moderate fret of 0.004 inch deep was observed at 221 degrees. Figure 7 gives a detailed view of the fretting.

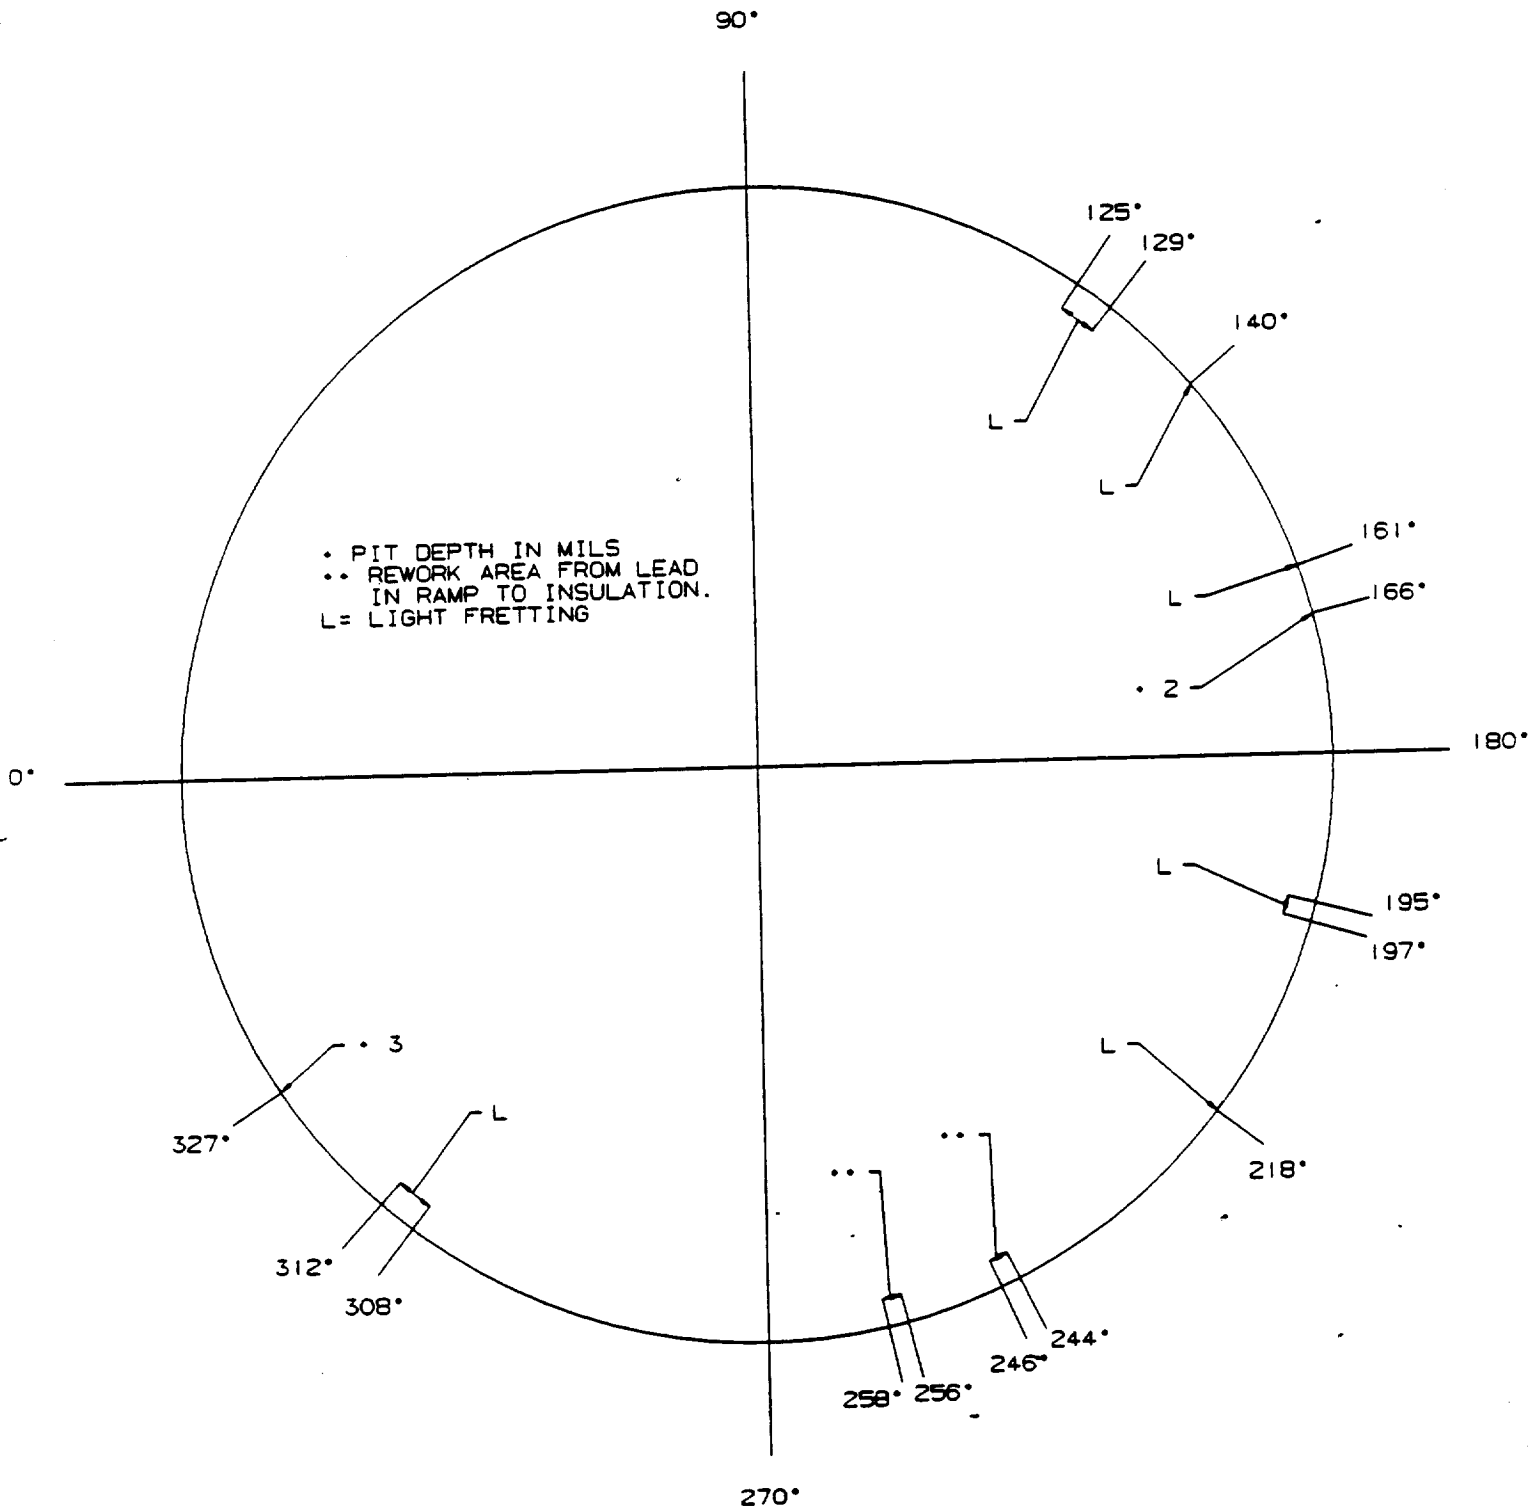
Figure 8. LH Aft Field Joint Fretting

Assessment of the metal components found light fretting at 125 though 129, 140, 161, 166, 195 though 197, 218, 244 though 246, 256 though 258, 308 though 312, and 327 degrees. This joint had fretting from a previous flight from 185 though 220 degrees. Figure 8 gives a detailed view of the fretting. All fretting was mapped on the clevis and it is assumed that the tang has similar damage to it.

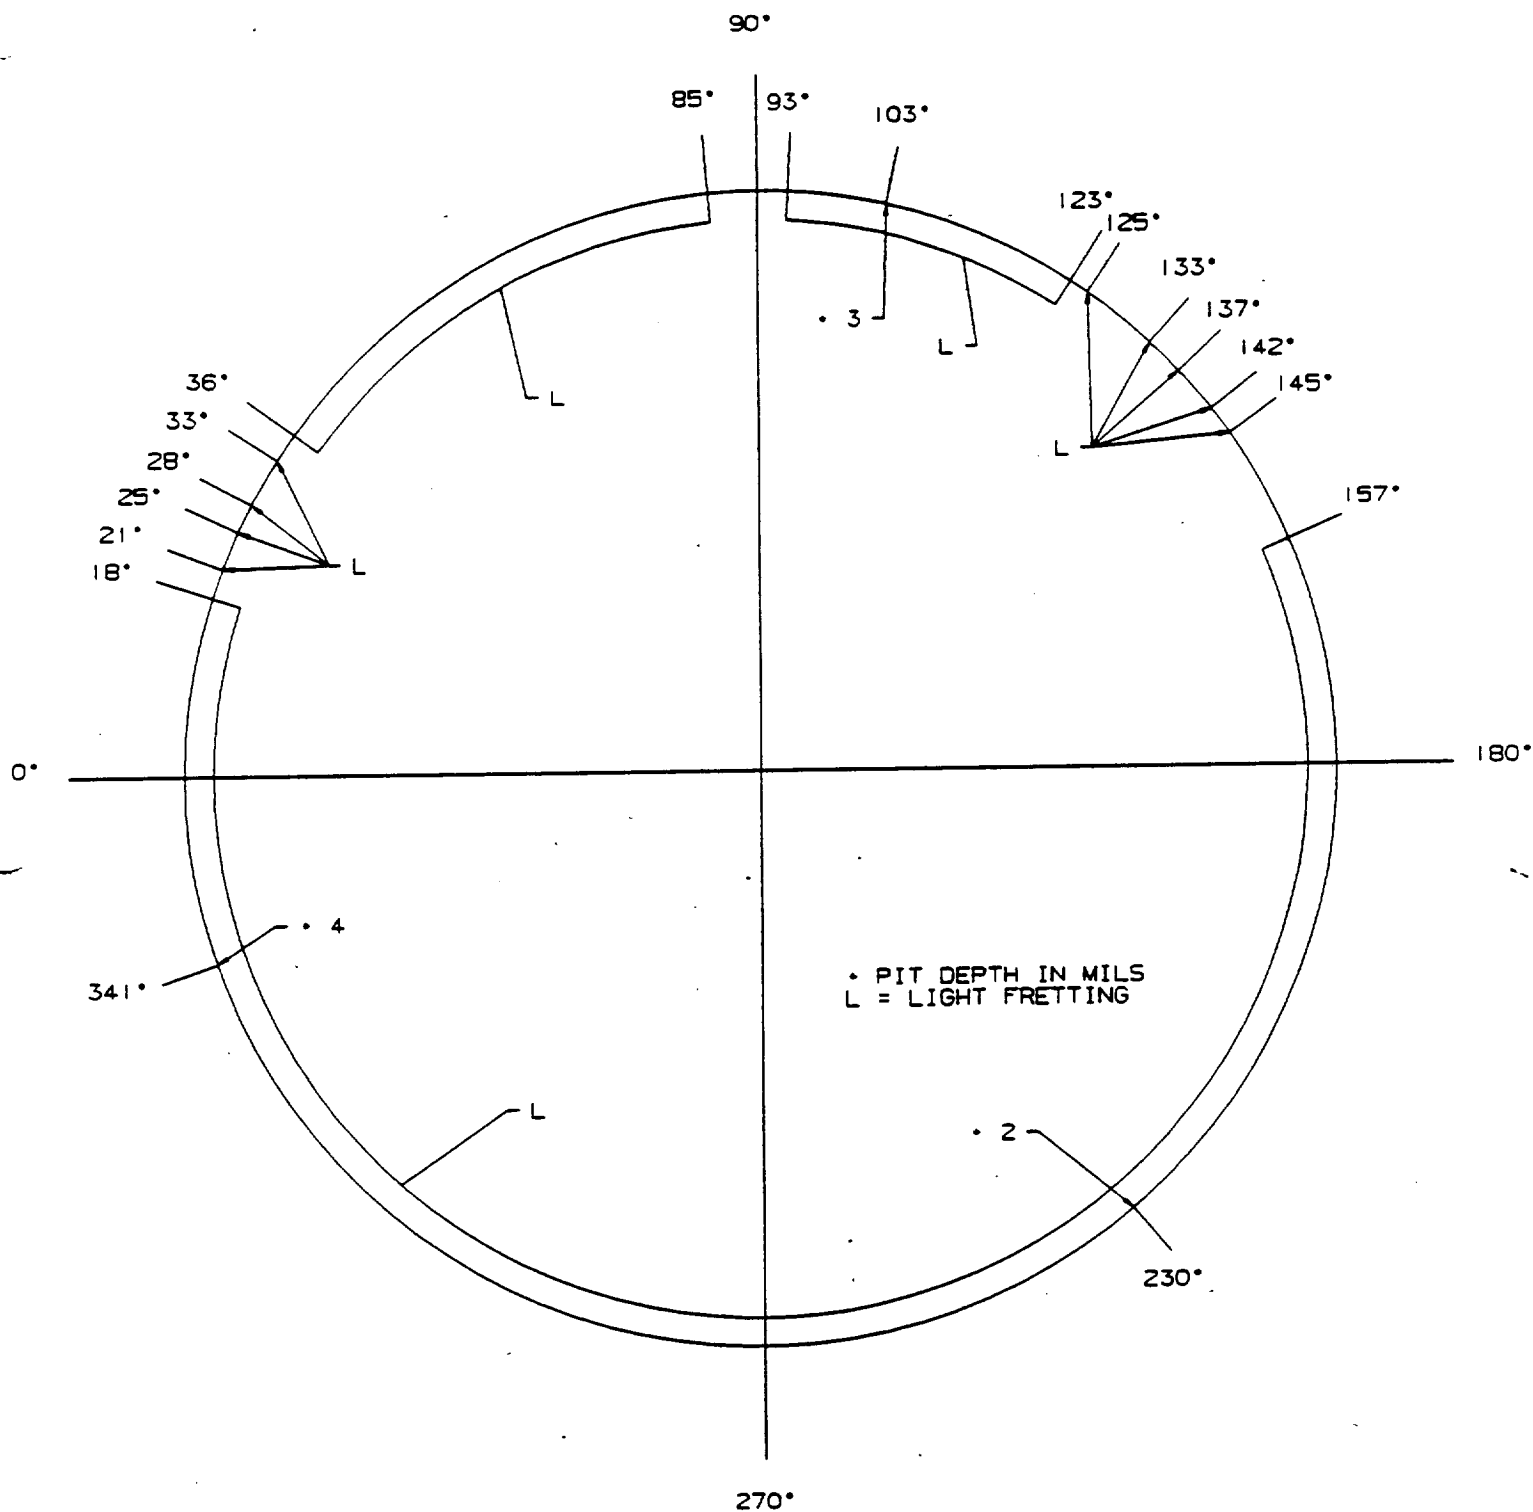
Figure 9. RH Forward Field Joint Fretting

Assessment of the metal components found light fretting intermittently the entire circumference of the joint. Figure 9 gives a detailed view of the fretting, all fretting was mapped on the clevis and it is assumed that the tang has similar damage to it.

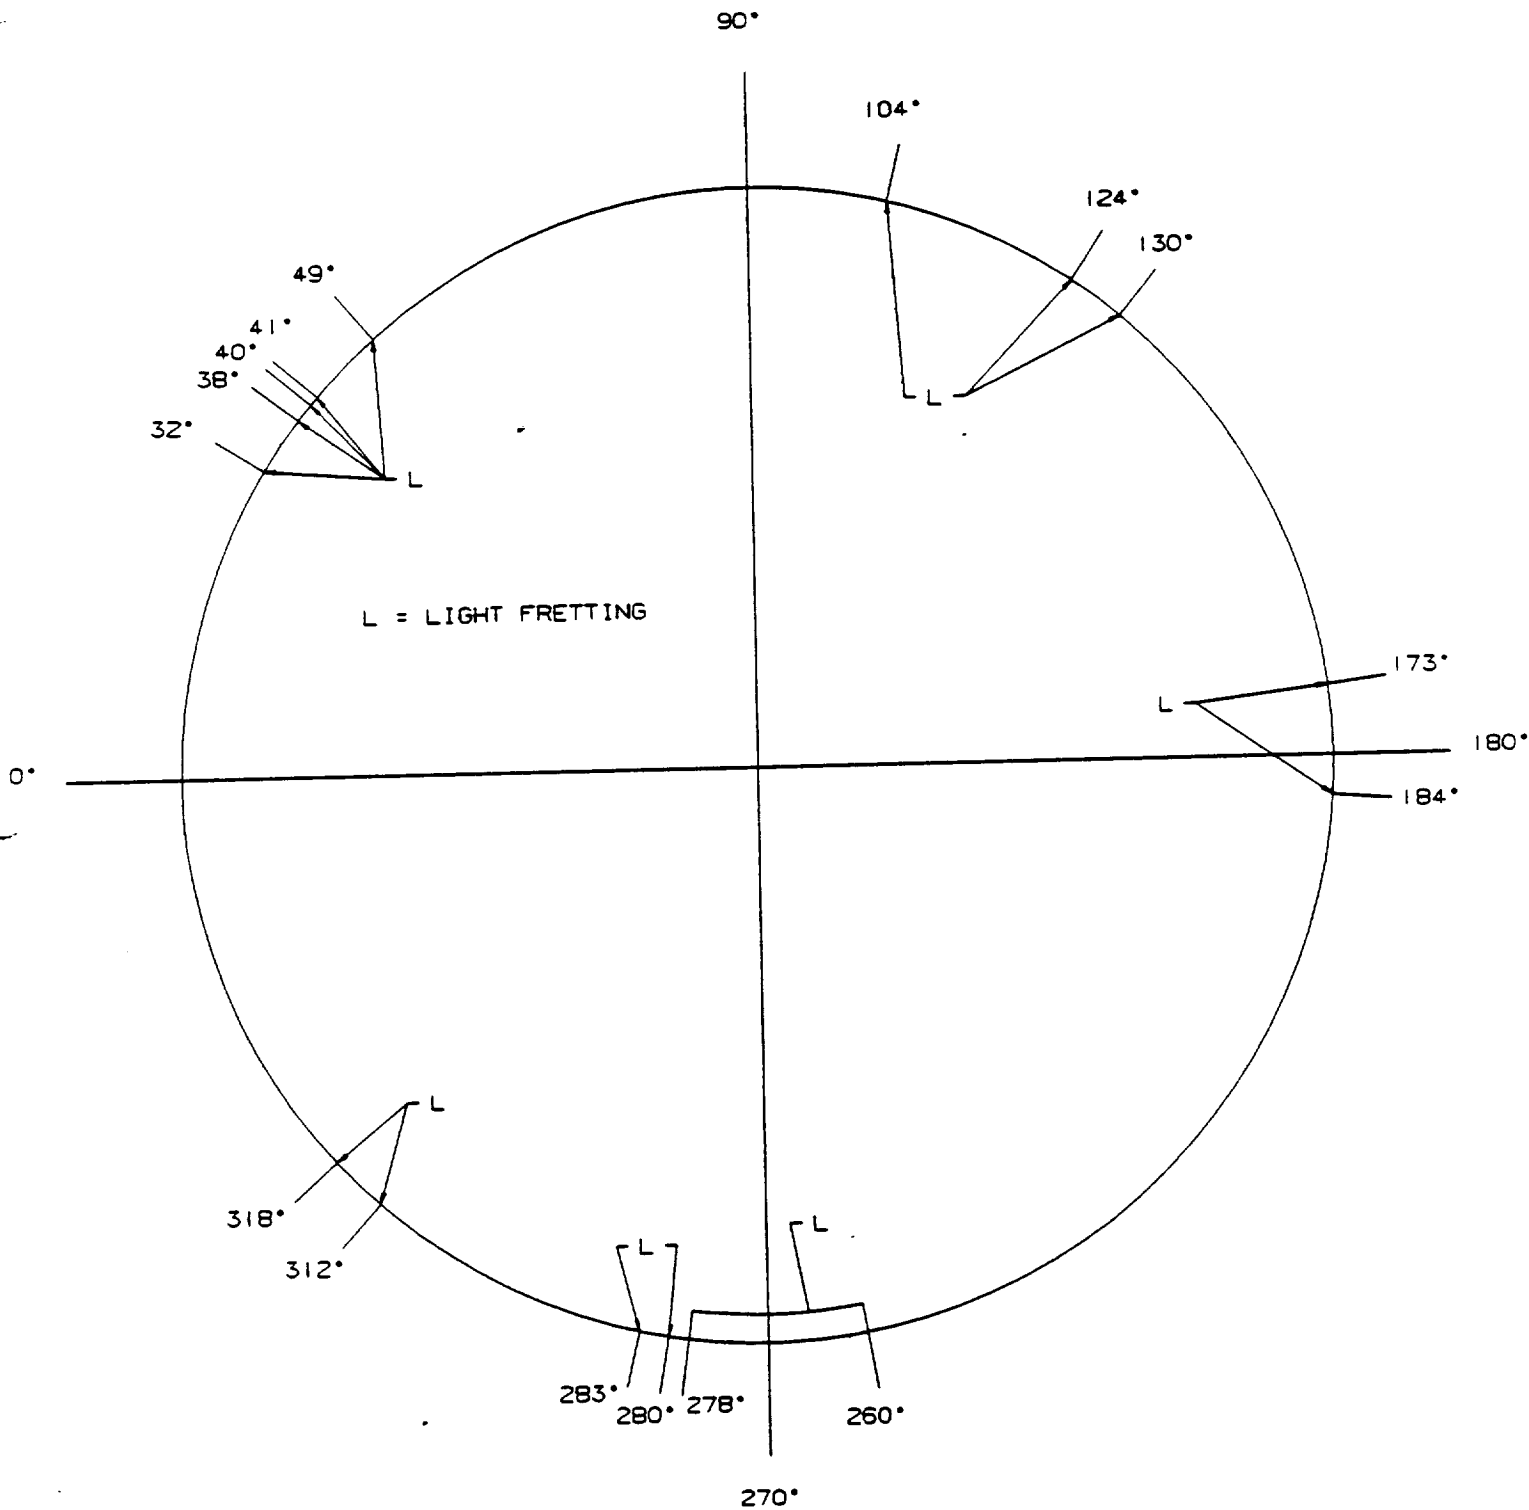
Figure 10. RH Aft Field Joint Fretting

Assessment of the metal components found light fretting at 32 to 41, 49, 104, 124, 130, 173, 184, 260 to 283, and 312 to 318 degrees. Figure 10 gives a detailed view of the fretting.
